ZWICK'S ISLAND LANDFILL
ENVIRONMENTAL INVESTIGATIONS
FINAL REPORT

ZWICK'S ISLAND LANDFILL
ENVIRONMENTAL INVESTIGATIONS

Waste Site Evaluation Unit
Waste Management Branch
Ontario Ministry of the Environment

Gartner Lee Limited

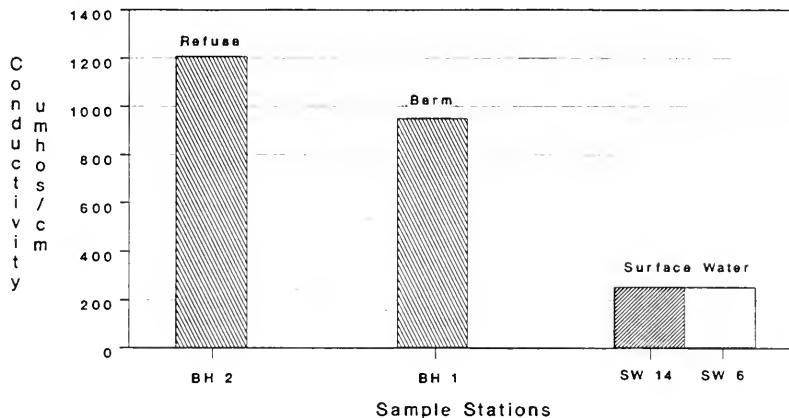
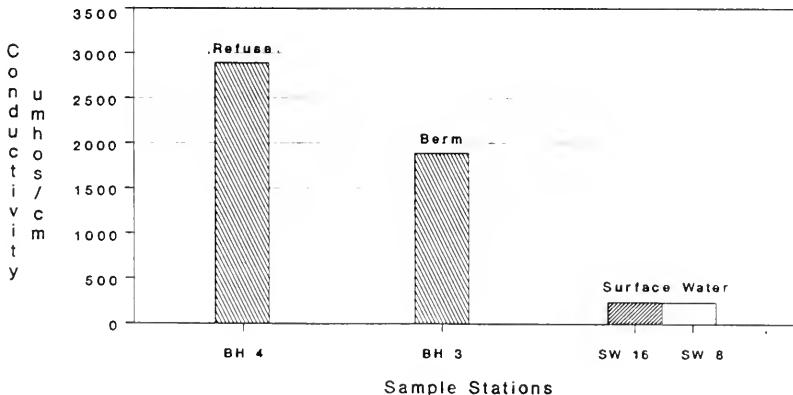
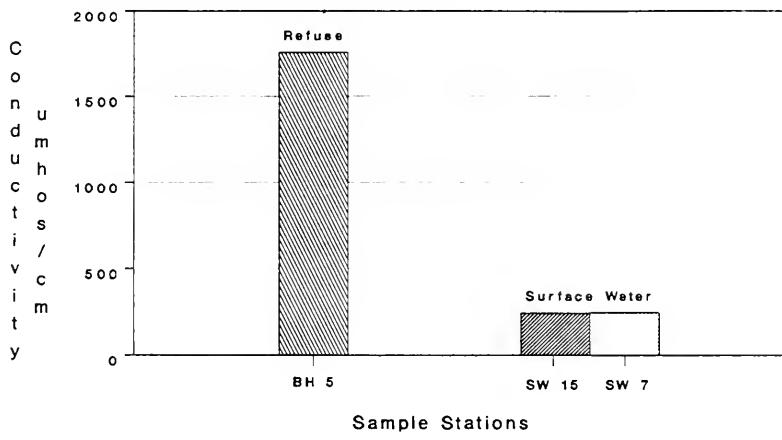
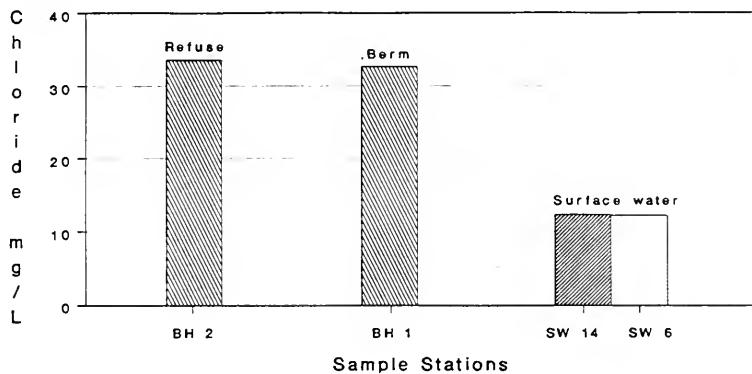
**FIGURE 7.1 COMPARISON OF CONDUCTIVITY LEVELS
ZWICKS ISLAND LANDFILL AUGUST 29-31, 1990**

Ground water conductivities varied from a low of 798 $\mu\text{S}/\text{cm}$ observed in BH 1 during the June sampling event, to an overall high of 2890 measured in BH 4 during the August sampling event. The values plotted in Figure 7.1 show that values decrease as potential for ground water dilution with bay water increases.

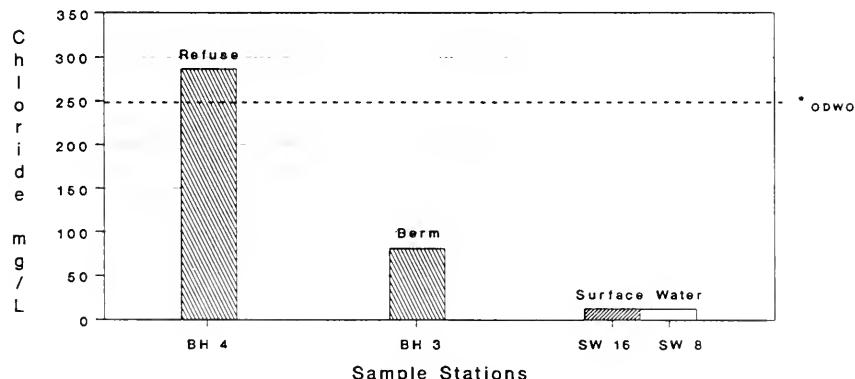
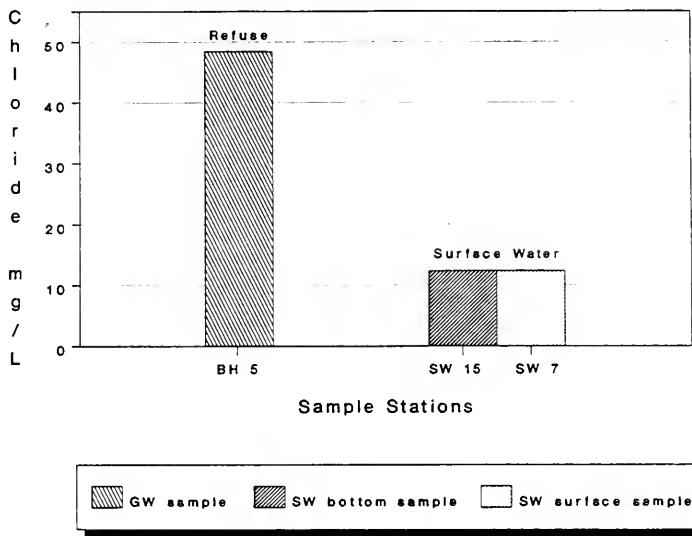
**FIGURE 7.2 : COMPARISON OF CHLORIDE CONCENTRATIONS
ZWICKS ISLAND LANDFILL AUGUST 29-31, 1990**

Chloride concentrations were observed to vary from an overall low of 14 mg/L in BH 2 during the June sampling event, to an overall high of 503 mg/L in BH 6 during the August sampling event. Viewed from the perspective that the maximum chloride value exceeded the ODWO limit for chloride by only approximately two times, the concentrations observed are small for ground water in contact with landfilled wastes.

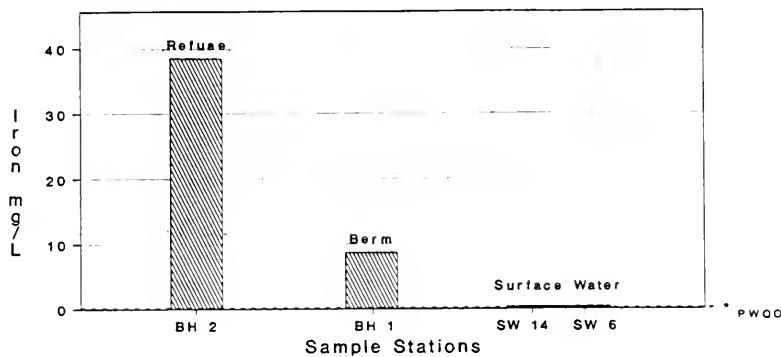
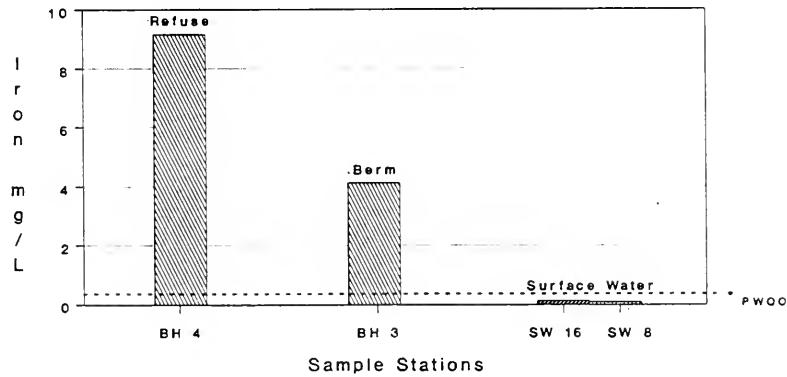
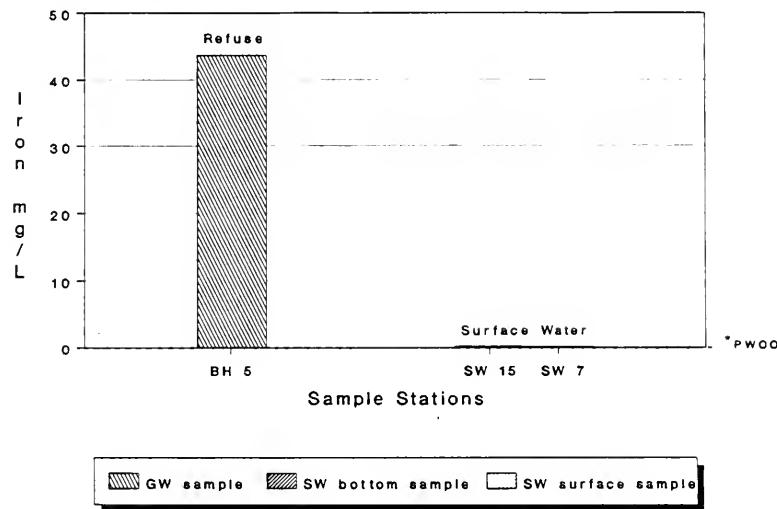
FIGURE 7.3 : COMPARISON OF IRON CONCENTRATIONS
ZWICKS ISLAND LANDFILL AUGUST 29-31, 1990

Iron concentrations varied from a low of 9.5 mg/L observed in BH 3 during the May sampling event to a high of 47.6 mg/L observed in BH 5 during the June sampling event.

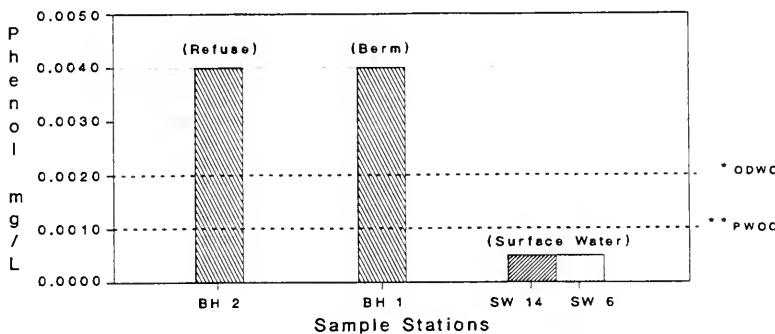
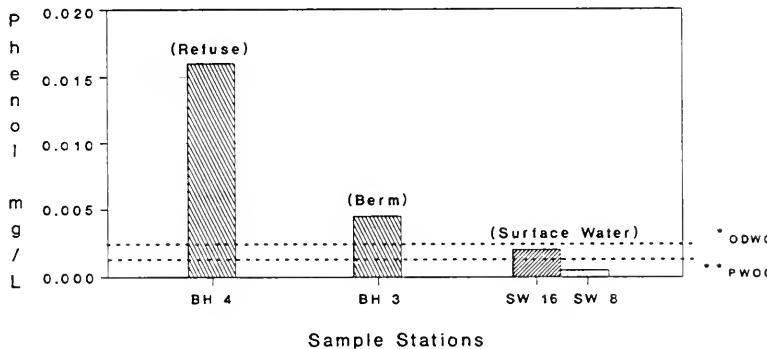
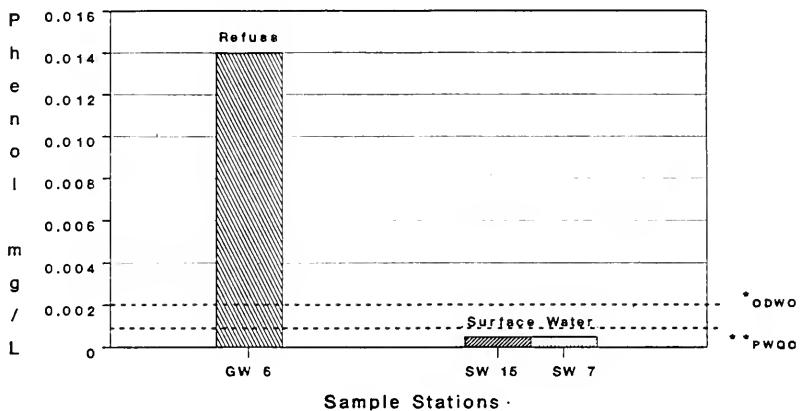
FIGURE 7.4 : COMPARISON OF PHENOL CONCENTRATIONS
ZWICKS ISLAND LANDFILL AUGUST 29-31, 1990

Phenol concentrations were observed to vary from less than the detection limit of 0.0005 mg/L measured in several monitors during the May and June sampling events, to a high of 0.0195 mg/L in BH 4 also during the June sampling event.

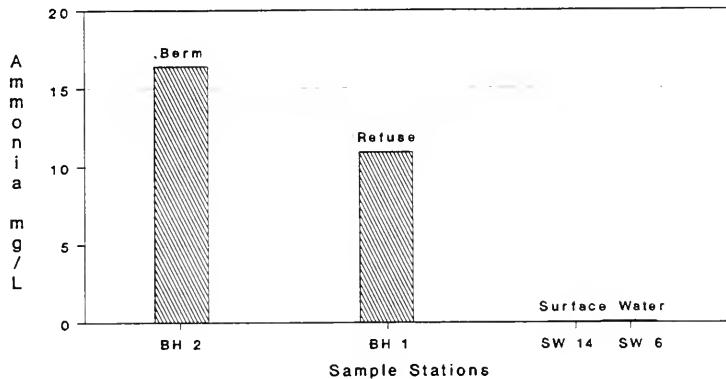
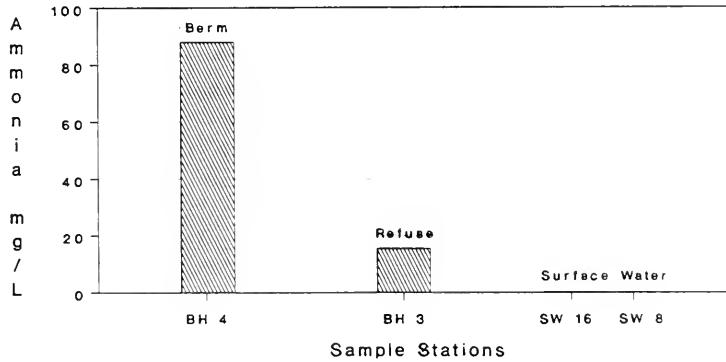
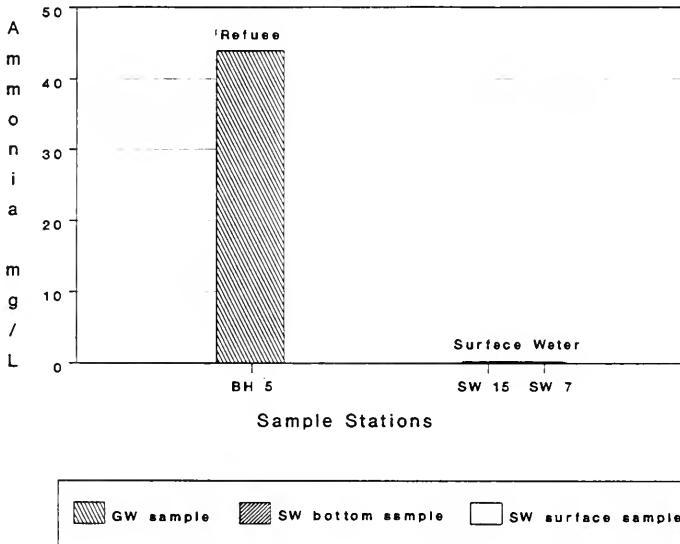
FIGURE 7.5 : COMPARISON OF AMMONIA CONCENTRATIONS
ZWICKS ISLAND LANDFILL AUGUST 29-31, 1900

As with many of the other parameters discussed, ammonia concentrations were found to decrease with decreasing distance of the sampling location to the bay. This trend is shown in Figure 7.5.

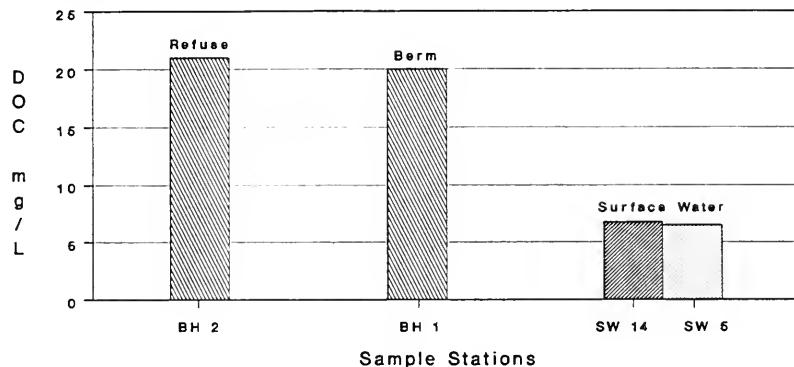
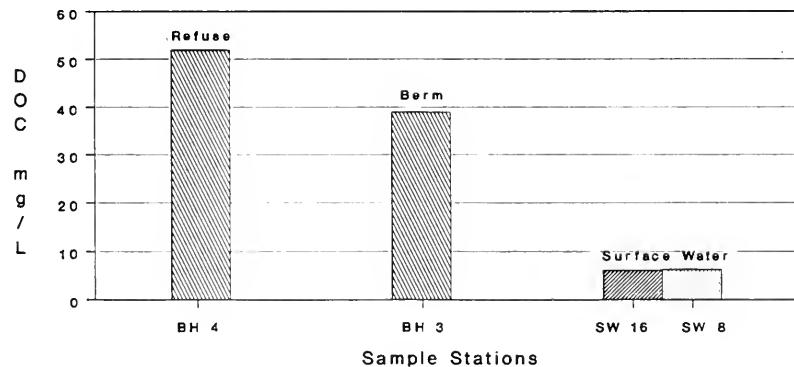
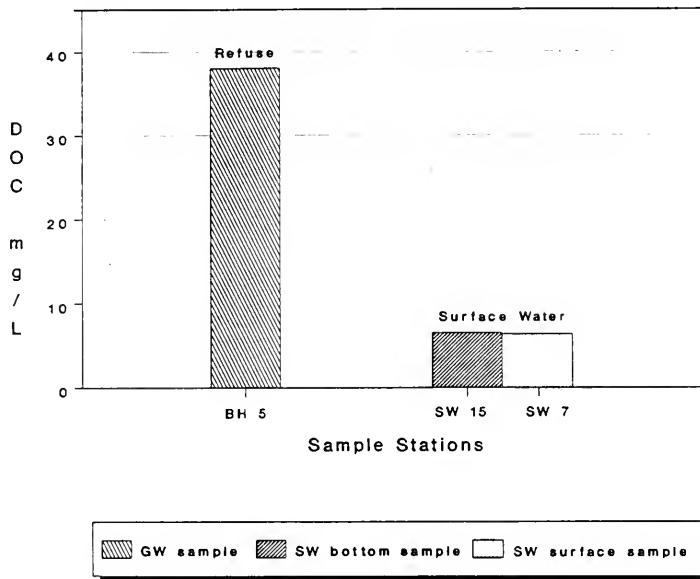
FIGURE 7.6 : COMPARISON OF DOC CONCENTRATIONS
ZWICKS ISLAND LANDFILL AUGUST 29-31, 1990

DOC concentrations ranged from a low of 7.4 mg/L measured in BH 7 in June, to a high of 52.0 mg/L measured in BH 4 in August. DOC analyses were not performed on samples recovered in May. TKN values varied from a low of 4.8 mg/L observed in BH 7 in June, to a high of 112 mg/L observed in BH 4 in August.

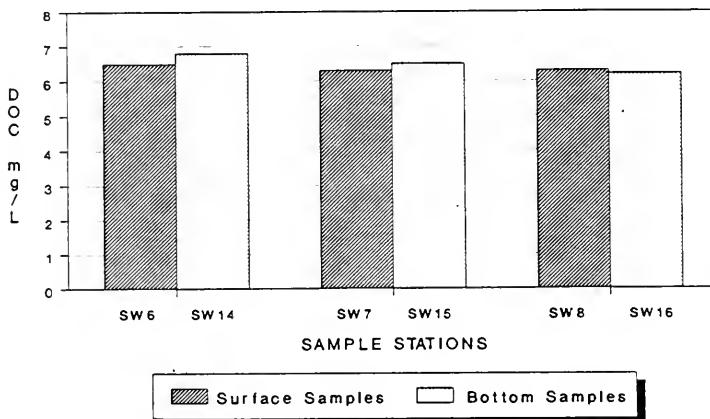
Figure 9.1: SURFACE WATER DOC CONCENTRATIONS
Comparison of Bottom and Surface Samples
Zwicks Island Landfill, August 1990

Figures 9.1 to 9.6 present a graphic representation for selected parameters of the August data from the surface and bottom samples. Generally there was little difference between the bottom and surface samples. DOC, Conductivity and Chloride showed surface and bottom concentrations approximately equal to each other. However, iron concentration were noticeably higher in bottom samples. This is likely a result of iron deposition through sedimentation processes and its release to surface water as a result of microbial activity and redox potential at the sediment water interface. Ammonia concentrations were observed to be slightly higher in the surface samples while TKN generally slightly higher in the bottom samples. The lower ammonia concentrations observed in the bottom samples could be a result of bacterial nitrification (Wetzel, 1983).

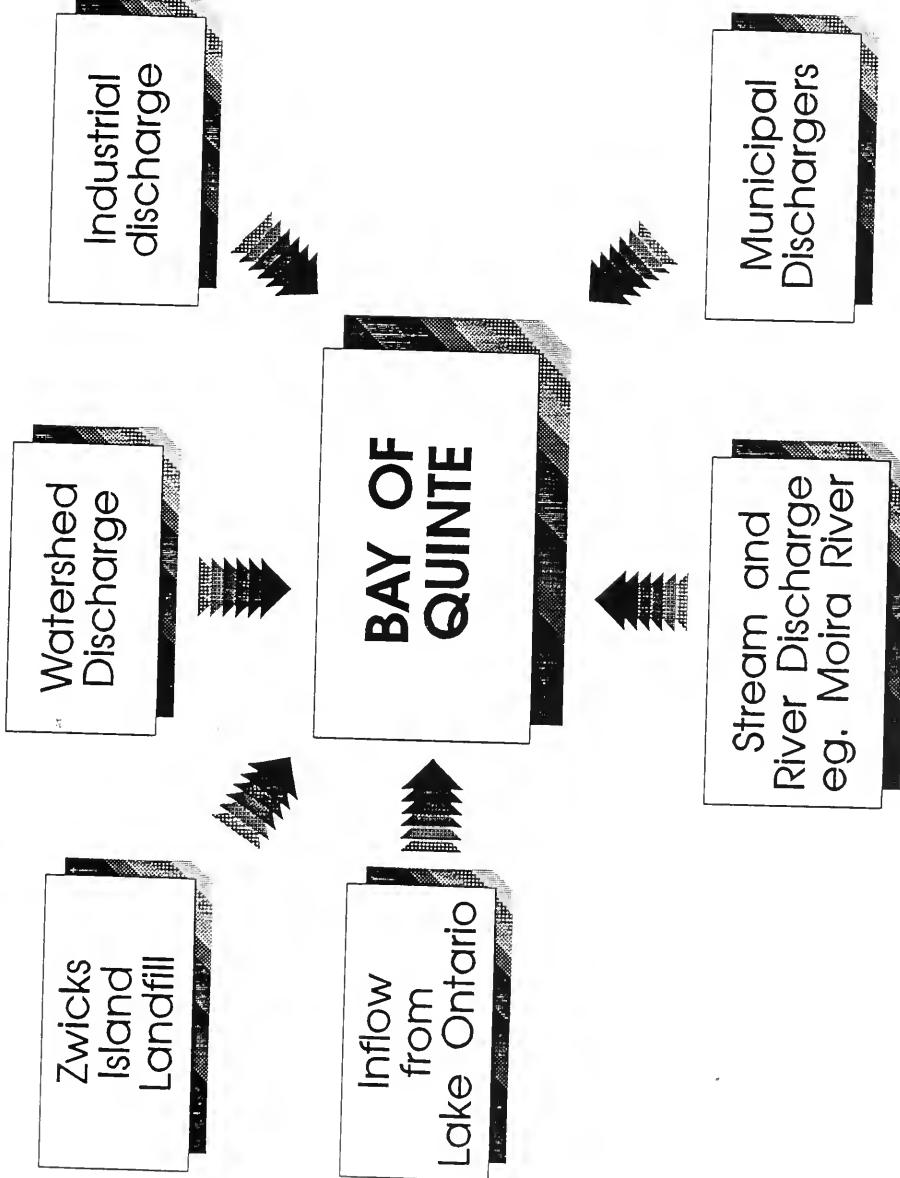
FIGURE 10

As discussed in Section 7.1.2 the flux of contaminants via ground water and from surface drainage represent the major pathways by which the Bay of Quinte is affected by Zwick's Island. These major pathways as well as other minor ones are graphically portrayed in Figure 10.
